Debris/Ice/TPS Assessment and Integrated Photographic Analysis of Shuttle Mission STS-88

**DEBRIS/ICE/TPS ASSESSMENT
AND
INTEGRATED PHOTOGRAPHIC ANALYSIS
OF
SHUTTLE MISSION STS-88**

4 December 1998

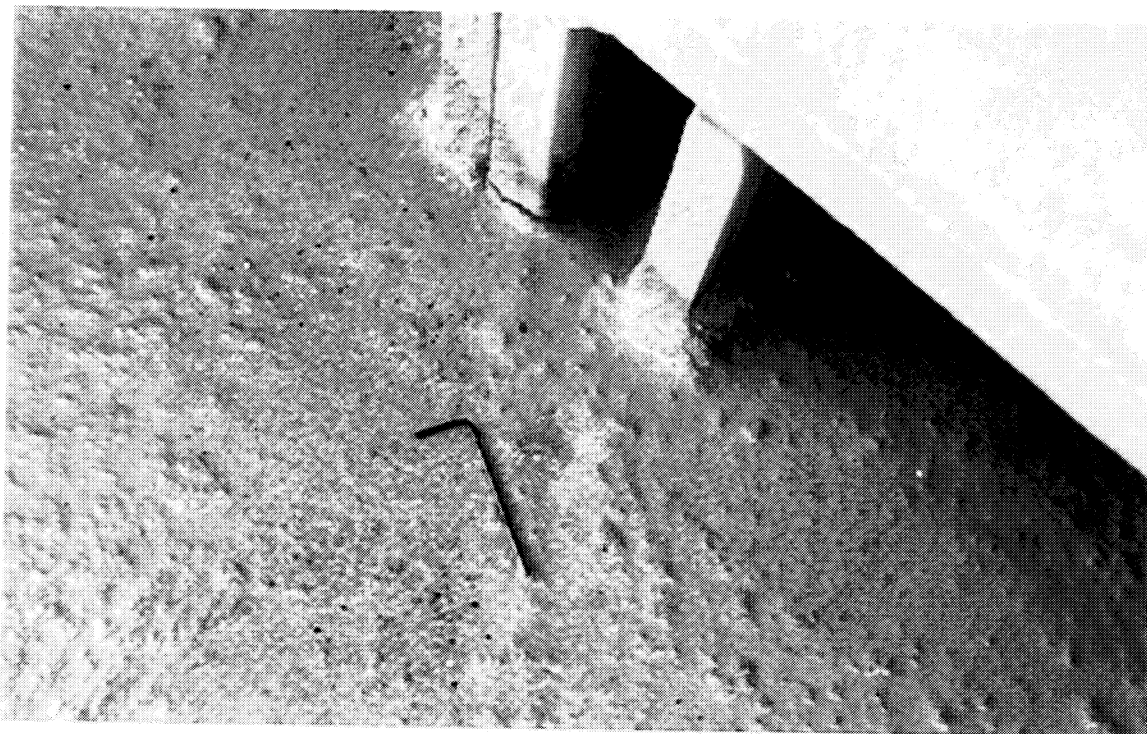
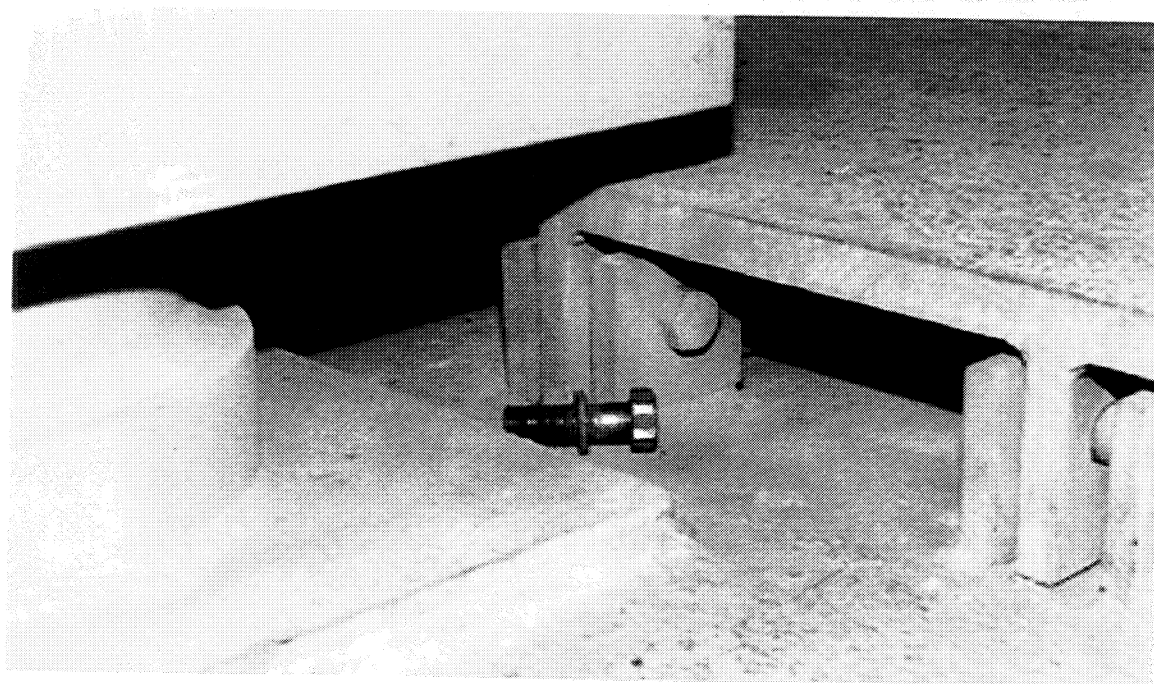
Photo 3: MLP Deck Debris

A small wrench and MLP deck bolt were found during the Pre-Launch Pad Inspection

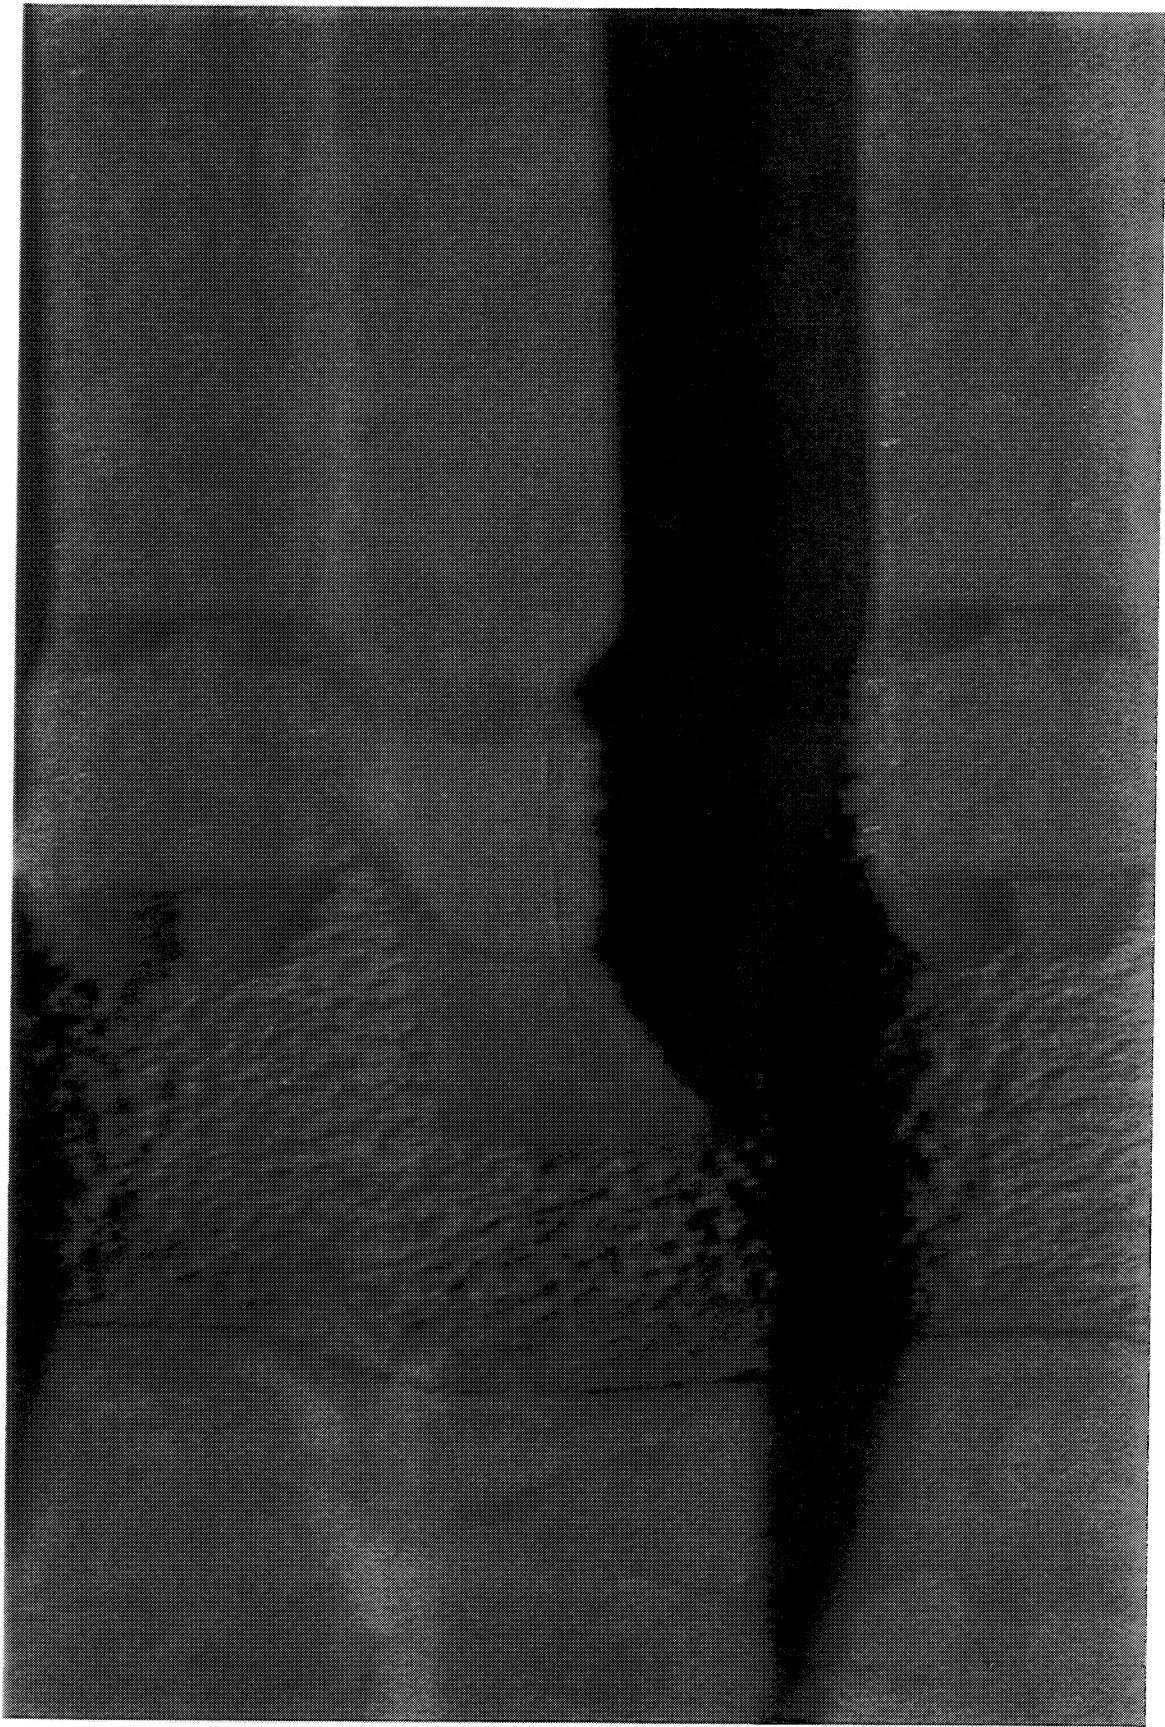
Photo 4: Crack in Intertank Foam

The only TPS item of note concerned a crack in a -Y+Z intertank stringer valley. The crack was approximately 8-10 inches long and was similar to those documented on previous vehicles.

One crack was present again in a stringer valley in the intertank -Y+Z quadrant. The crack appeared to originate from the as-sprayed foam at the aft end of the stringer extending forward approximately 10-12 inches from the LH2 tank splice. The crack, which had elongated an additional two inches from that observed during the previous cryoload, was less than 1/16-inch wide with no visible offset or ice/frost formation. The crack was acceptable for flight per the NSTS-08303 criteria and SLWT tanking test IPR rationale.

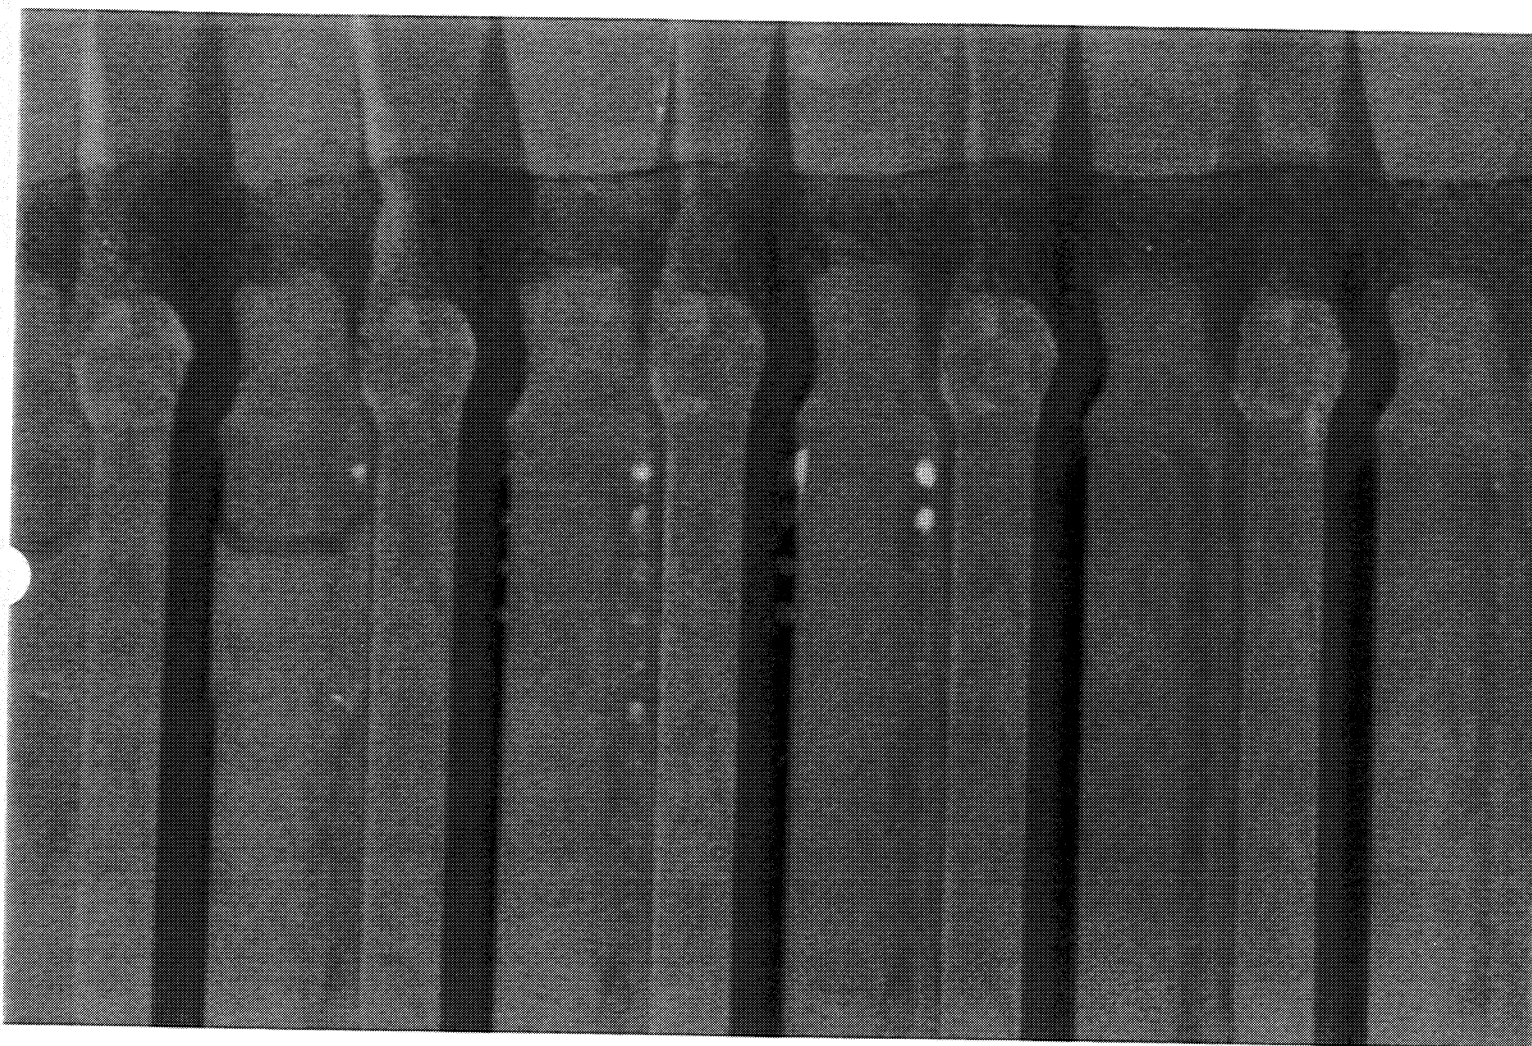
Photo 6: Frost on Intertank

Numerous frost spots had formed along three intertank stringers near the LO2 tank-to-intertank flange closeout in the -Y-Z quadrant.

Numerous frost spots had formed along three intertank stingers near the LO2 tank-to-intertank flange closeout in the -Y-Z quadrant.

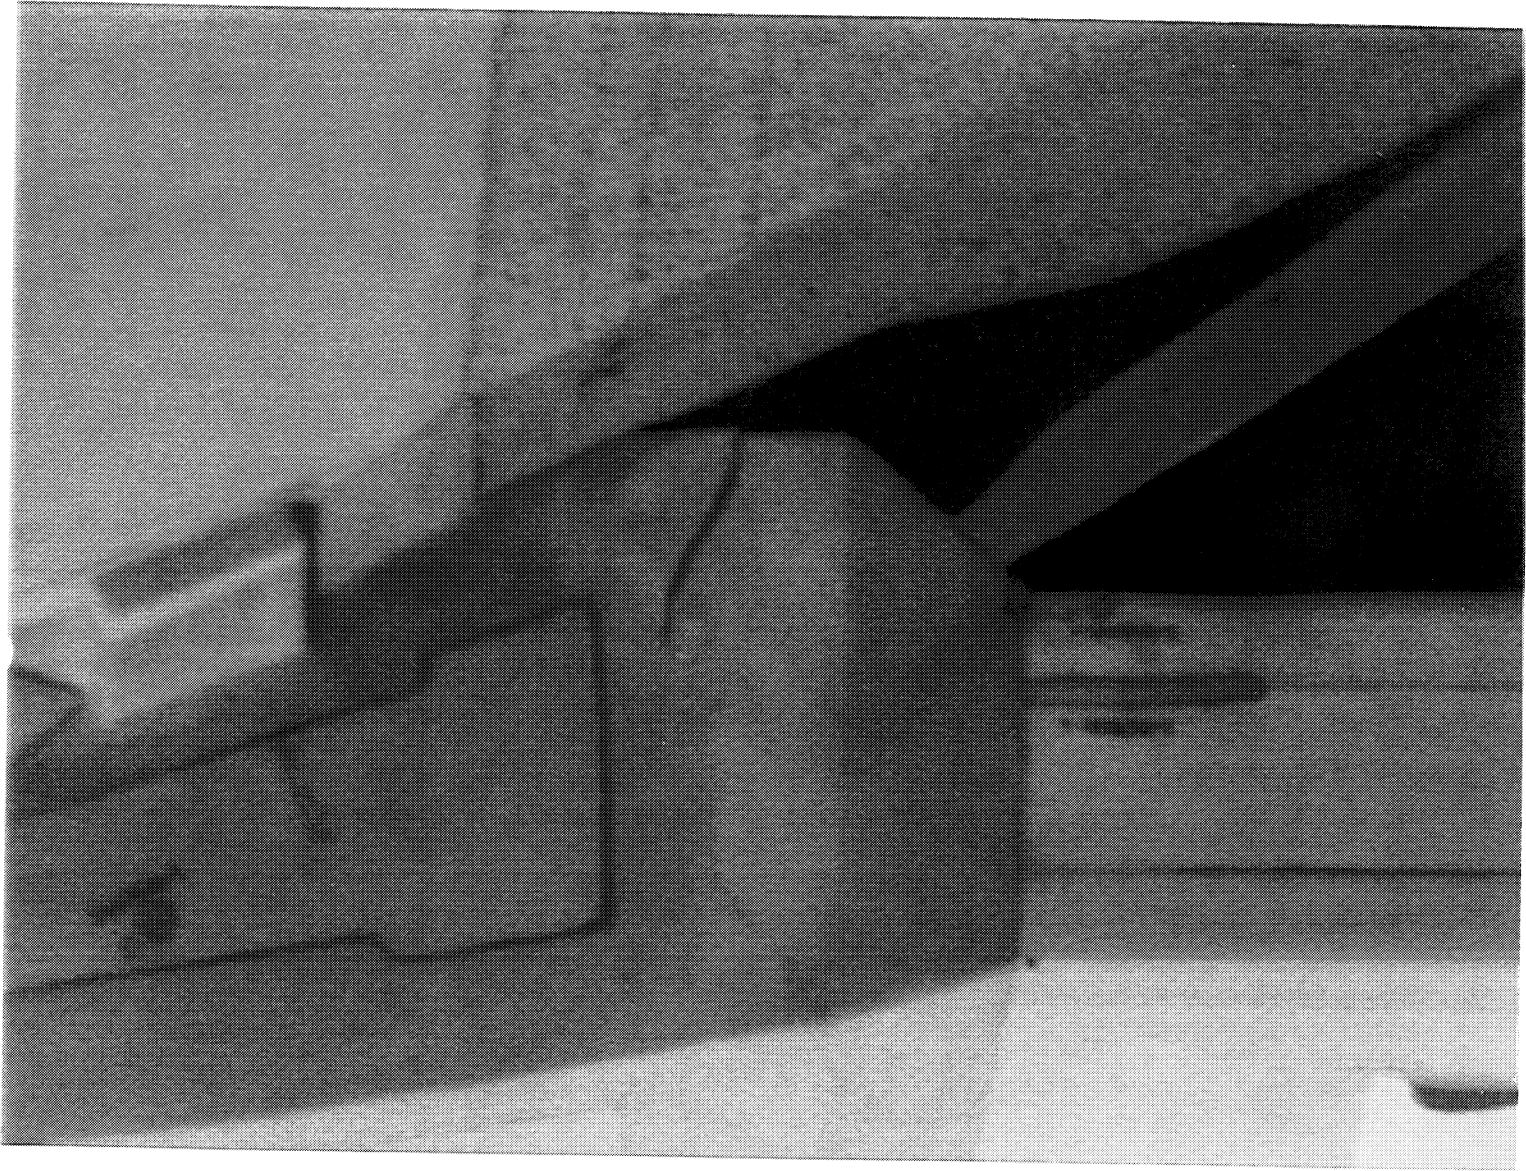
Photo 7: -Y Vertical Strut

A 8-inch long by 3/8-inch wide stress relief crack had formed, as expected, on the -Y vertical strut forward facing TPS. There was no ice/frost present and no offset. The condition was acceptable for launch per the NSTS-08303 criteria.

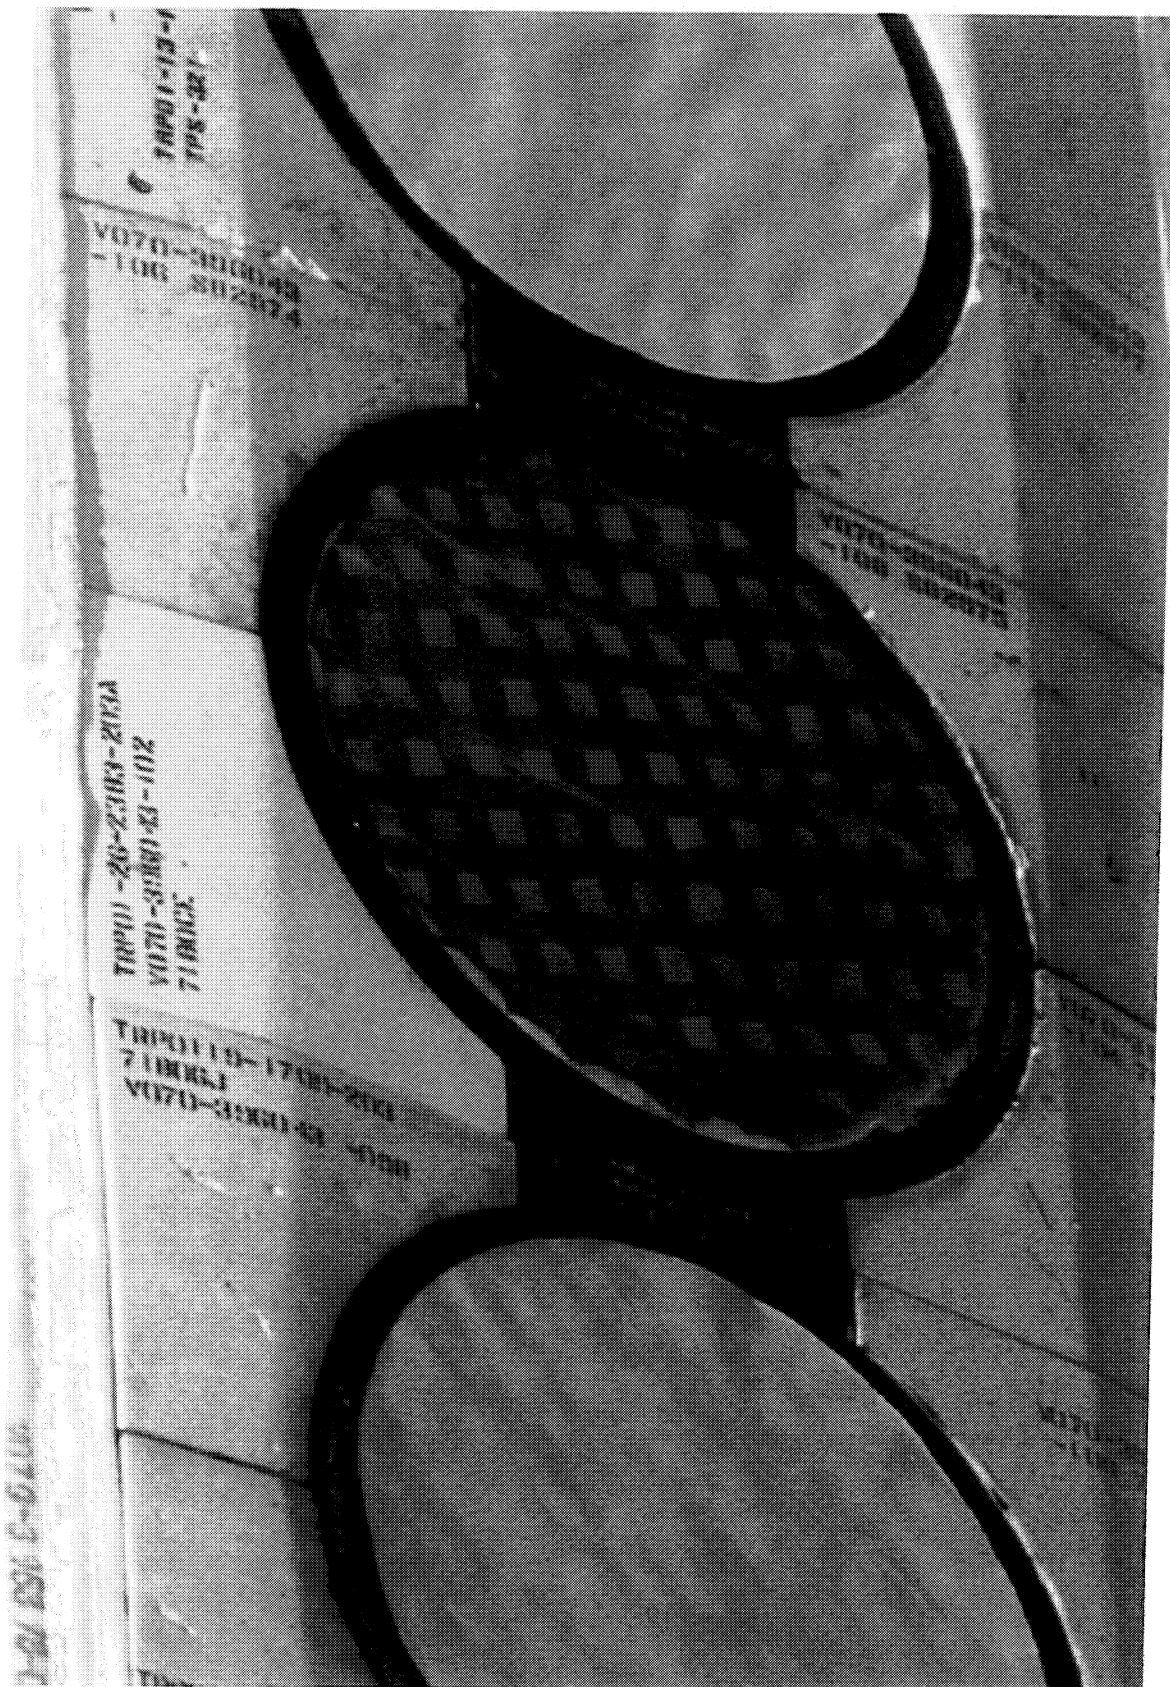
Photo 9: RCS Thruster R2R

All RCS thruster covers were intact. The paper cover on thruster R2R was very wet and exhibited a liquid level line.

RCS thruster R2R was leaking with a visible liquid level line during the Final Inspection. SSME ignition caused the thruster paper cover to rupture and liquid to drain from the thruster nozzle prior to liftoff (OTV 070).

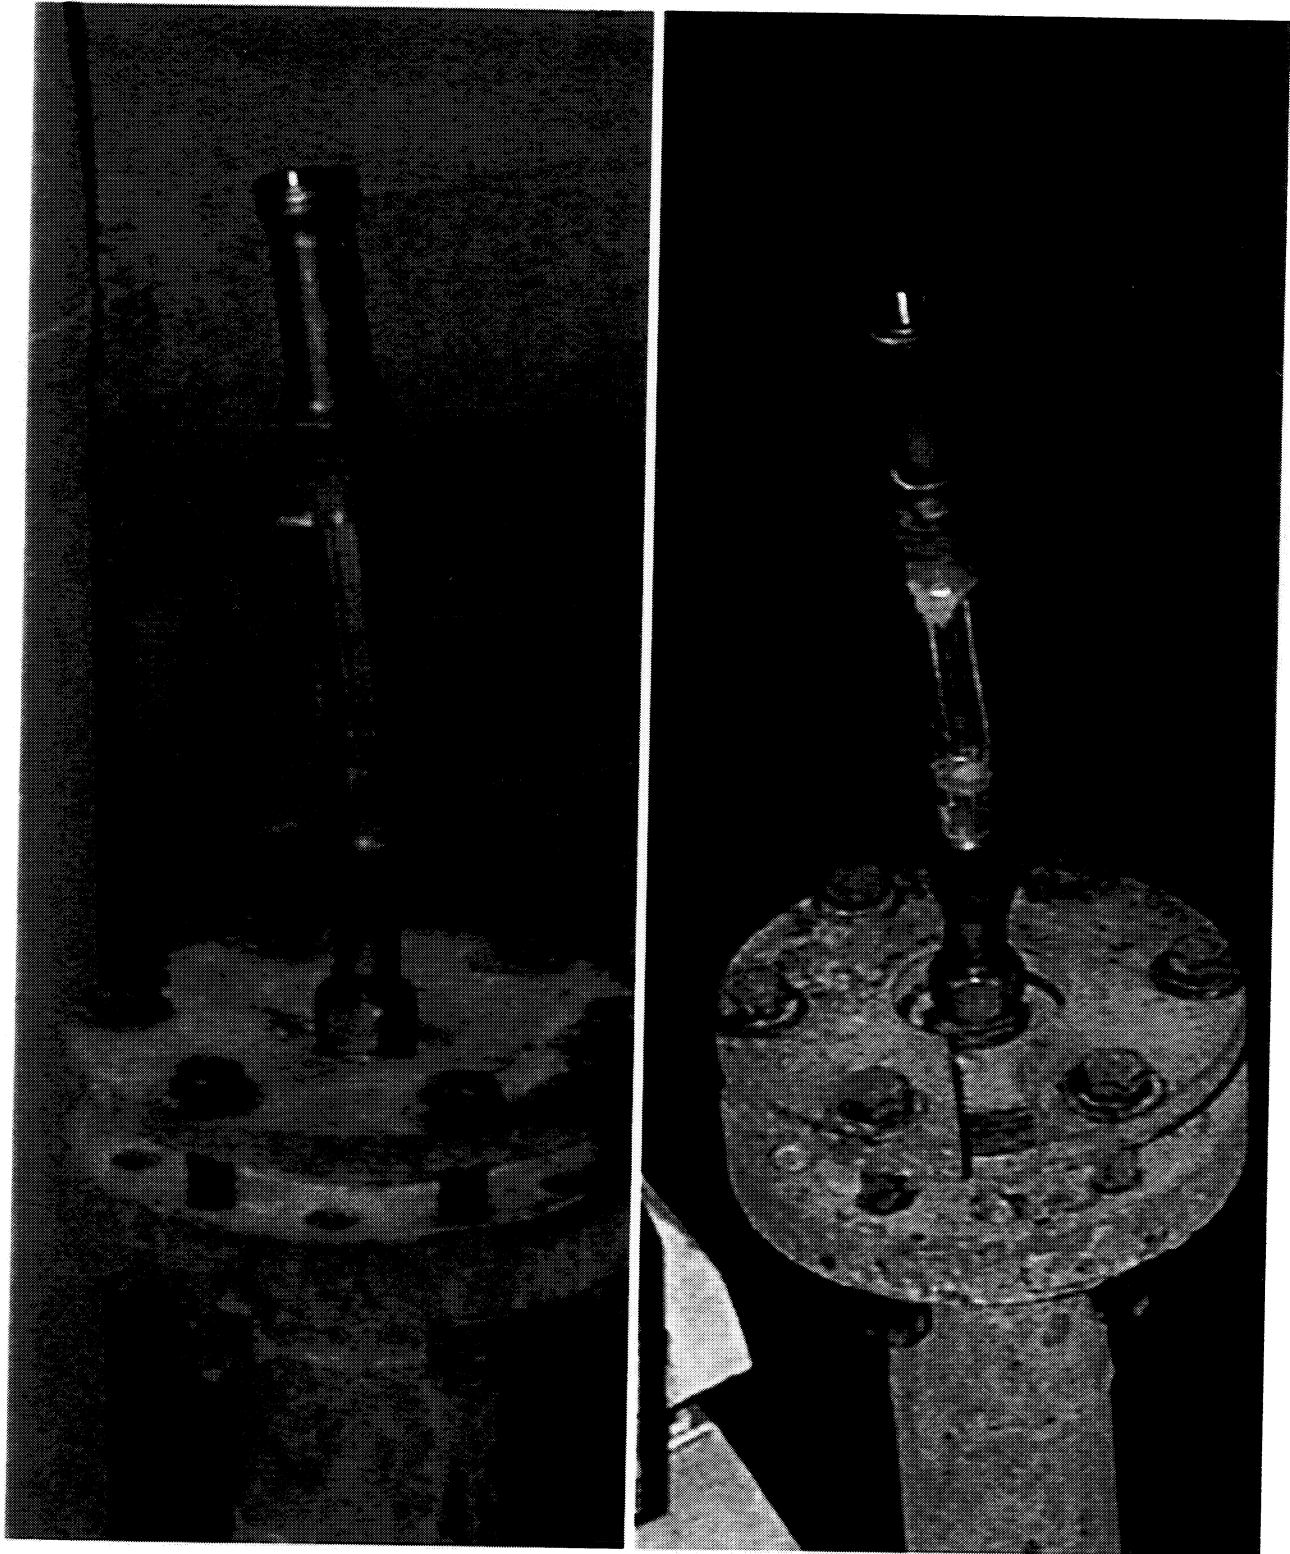
Photo 10: Aft Skirt GN2 Purge Lines

The right SRB aft skirt GN2 purge line was intact, though 80 percent of the protective tape was eroded away and the line was slightly bent at the lower end. The left GN2 purge flex line was also intact though 90 percent of the protective tape had eroded.

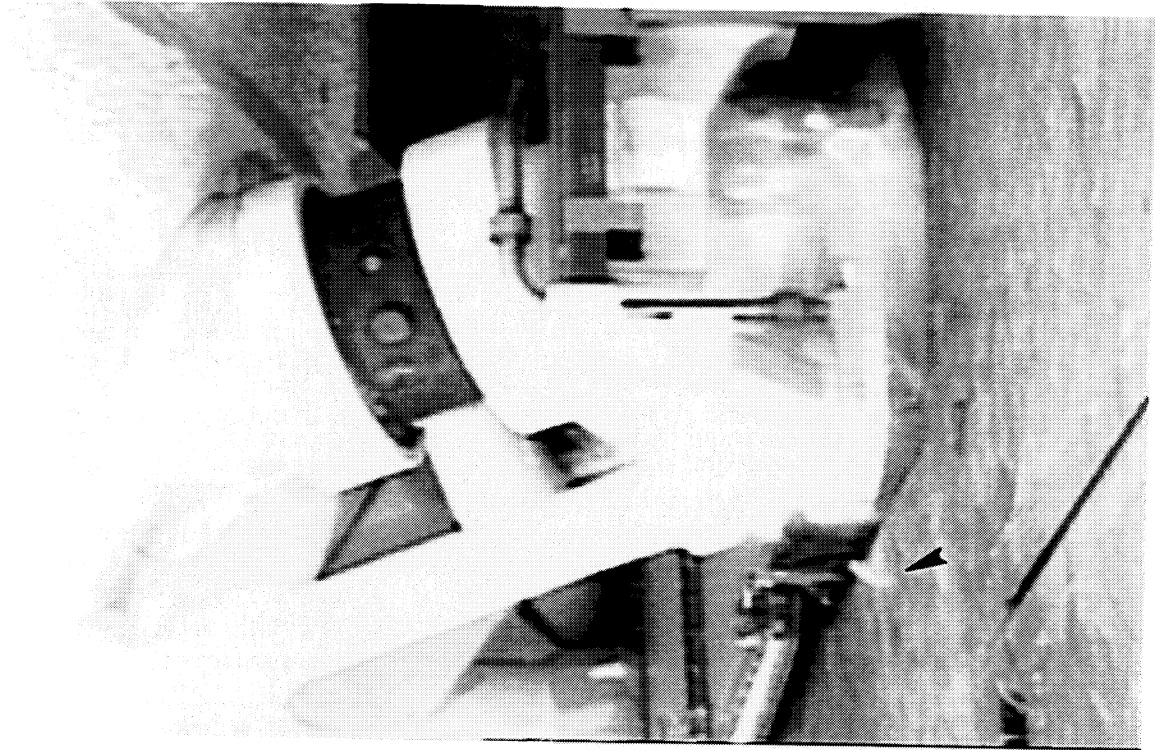
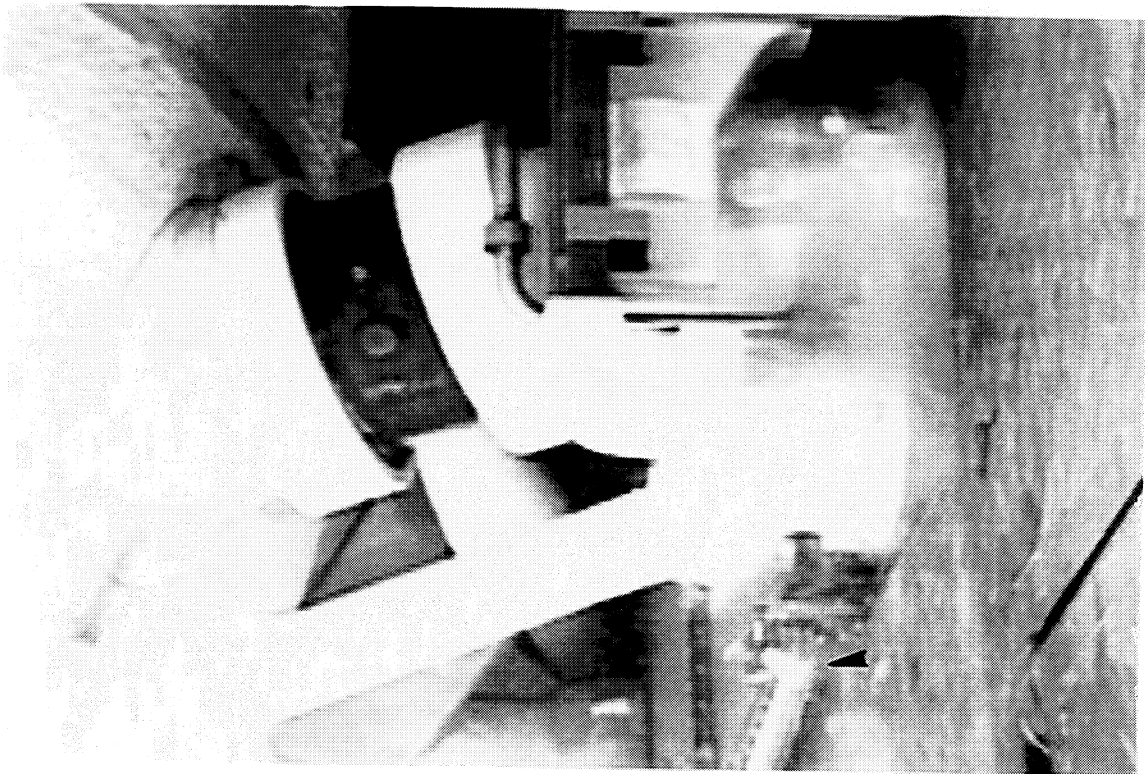
Photo 11: LH2 ET/ORB Umbilical

SSME ignition caused numerous pieces of ice from the LH2 ET/ORB umbilical to fall aft. Some pieces impacted the umbilical cavity sill, but no damage was visible. Two pieces of umbilical purge barrier mylar tape, one each from inboard and outboard sides of the LH2 ET/ORB umbilical, fell aft (OTV-009, 053, 063).

Two pieces of umbilical purge barrier mylar tape, one each from inboard and outboard sides of the LH2 ET/ORB umbilical, fell aft during SSME ignition

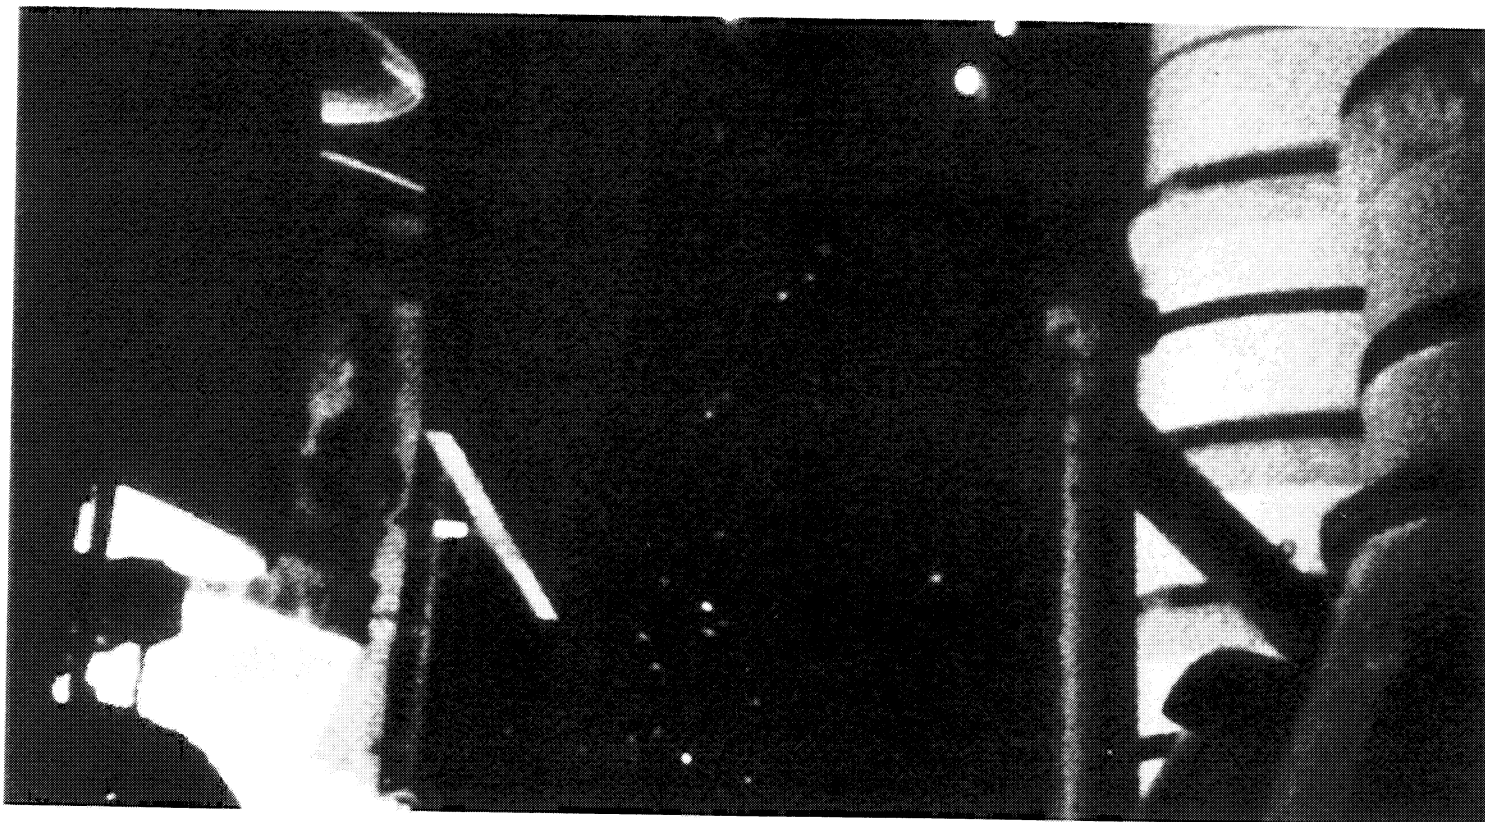
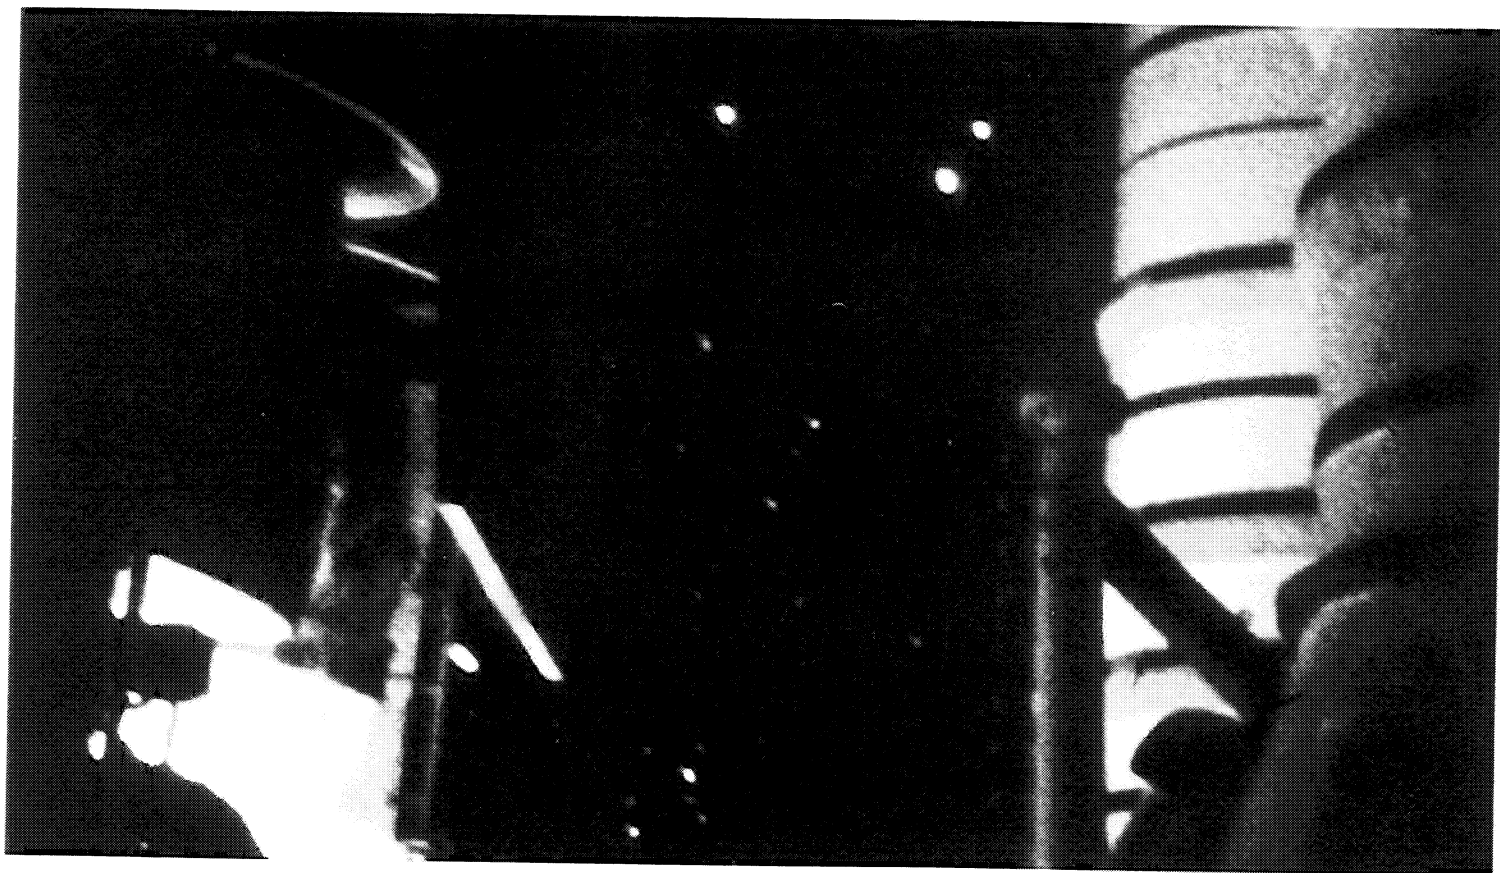
Photo 12: White Object Near Body Flap

A thin, white on one side, rectangular object, estimated to be 6 inches long by 3 inches wide, appeared to originate from the body flap hinge near SSME #3 at 08:35:31.778 UTC. This same object could also be seen in film E-19 and E-52 at 08:35:31.831 UTC. Other films of the base heat shield area (from a distance) showed no missing tiles, so the object is believed to be a gap filler or GSE tile shim.

A thin, white on one side, rectangular object, estimated to be 6 inches long by 3 inches wide, appeared to originate from the body flap hinge near SSME #3 at 08:35:31.778 UTC. Other films of the base heat shield area (from a distance) showed no missing tiles, so the object is believed to be a gap filler or GSE tile shim.

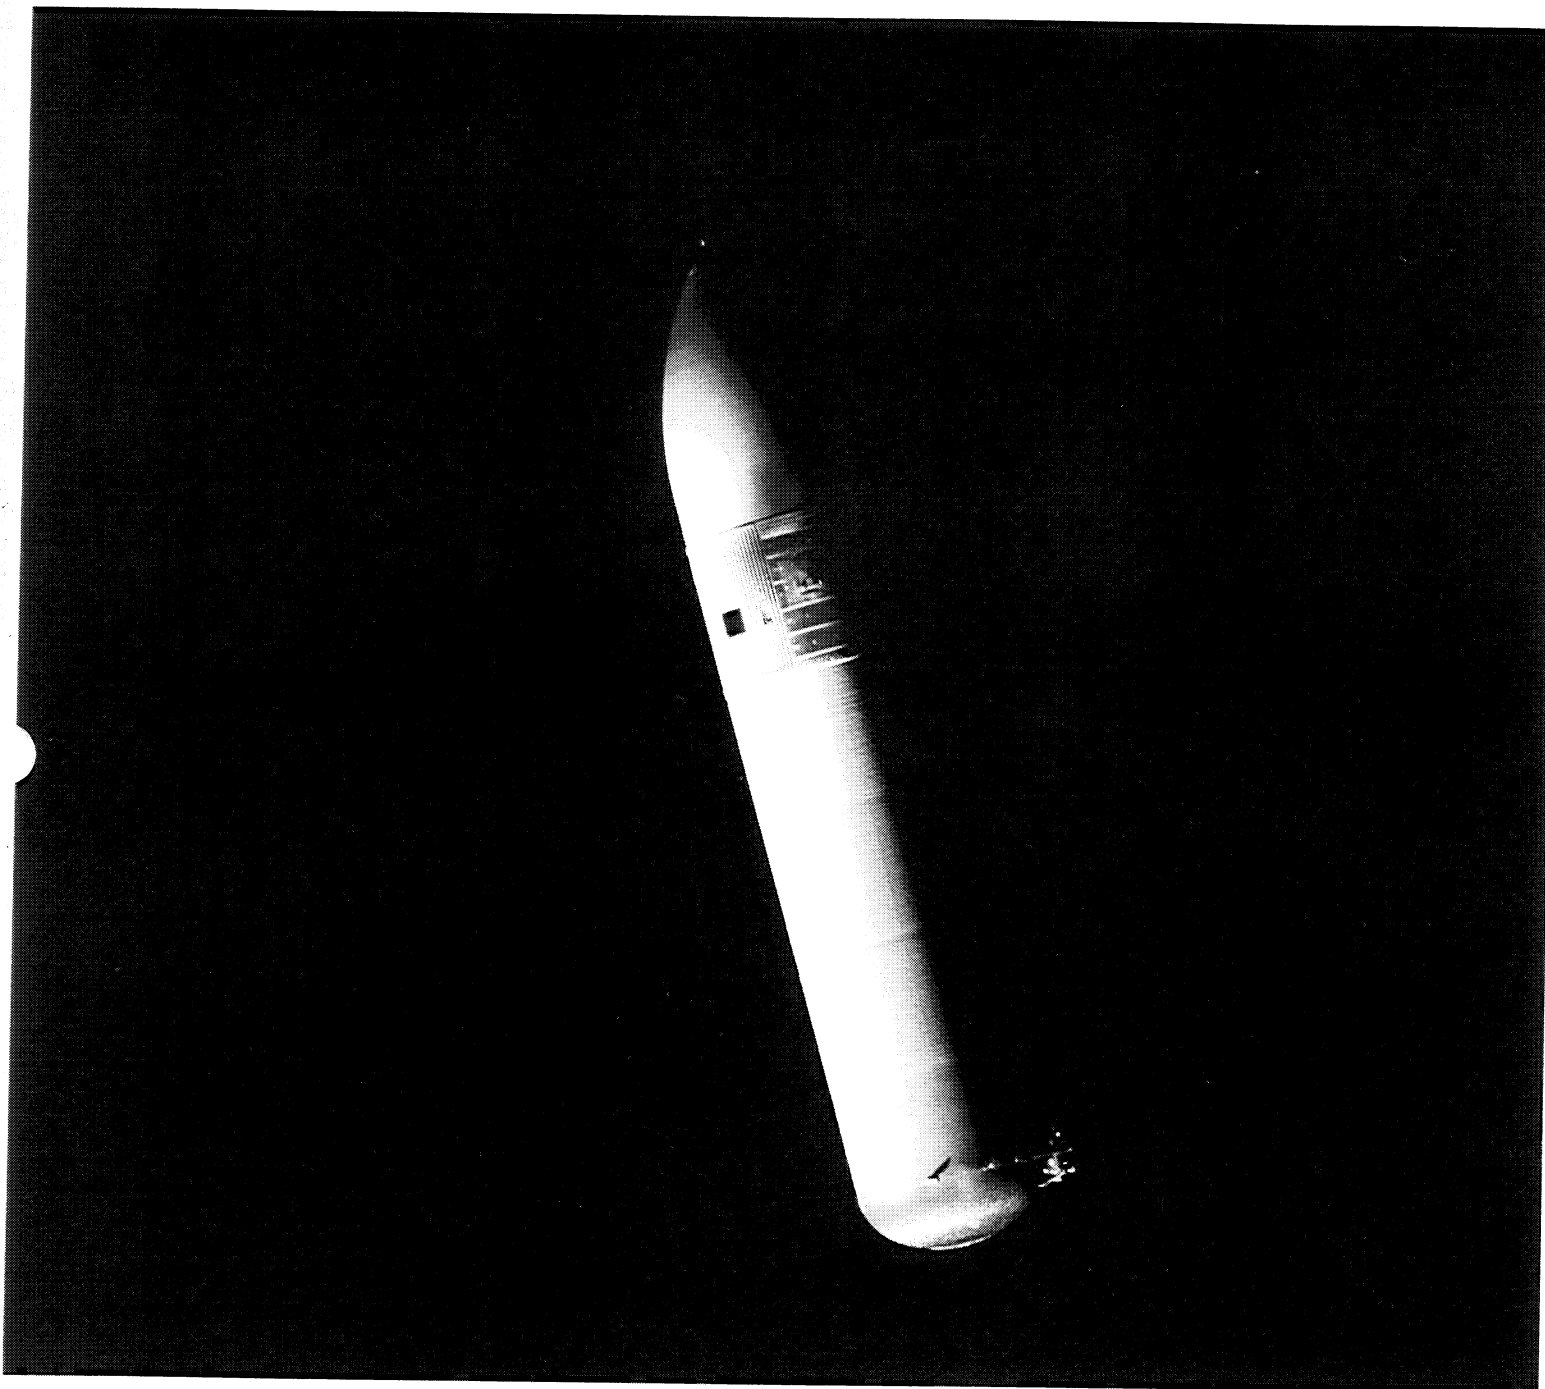
Photo 14: ET -Y Thrust Panel

Two frames of the -Y thrust panel showed the acreage aft of the EB fitting was generally in good condition. Several divots 2-3 inches in size could be discerned in thrust panel TPS to the -Z side of the EB fitting and forward of the fitting.

This view of the -Y thrust panel showed the acreage aft of the EB fitting generally in good condition. Several divots could be discerned in thrust panel TPS to the -Z side of the EB fitting and forward of the fitting. Note the 10-inch divot in the forward part of the LH2 tank-to-intertank flange and extending forward into the -Y thrust panel acreage

The External Tank Project continues to work an IFA to prevent loss of foam from the ET thrust panels and preclude further damage to Orbiter tiles

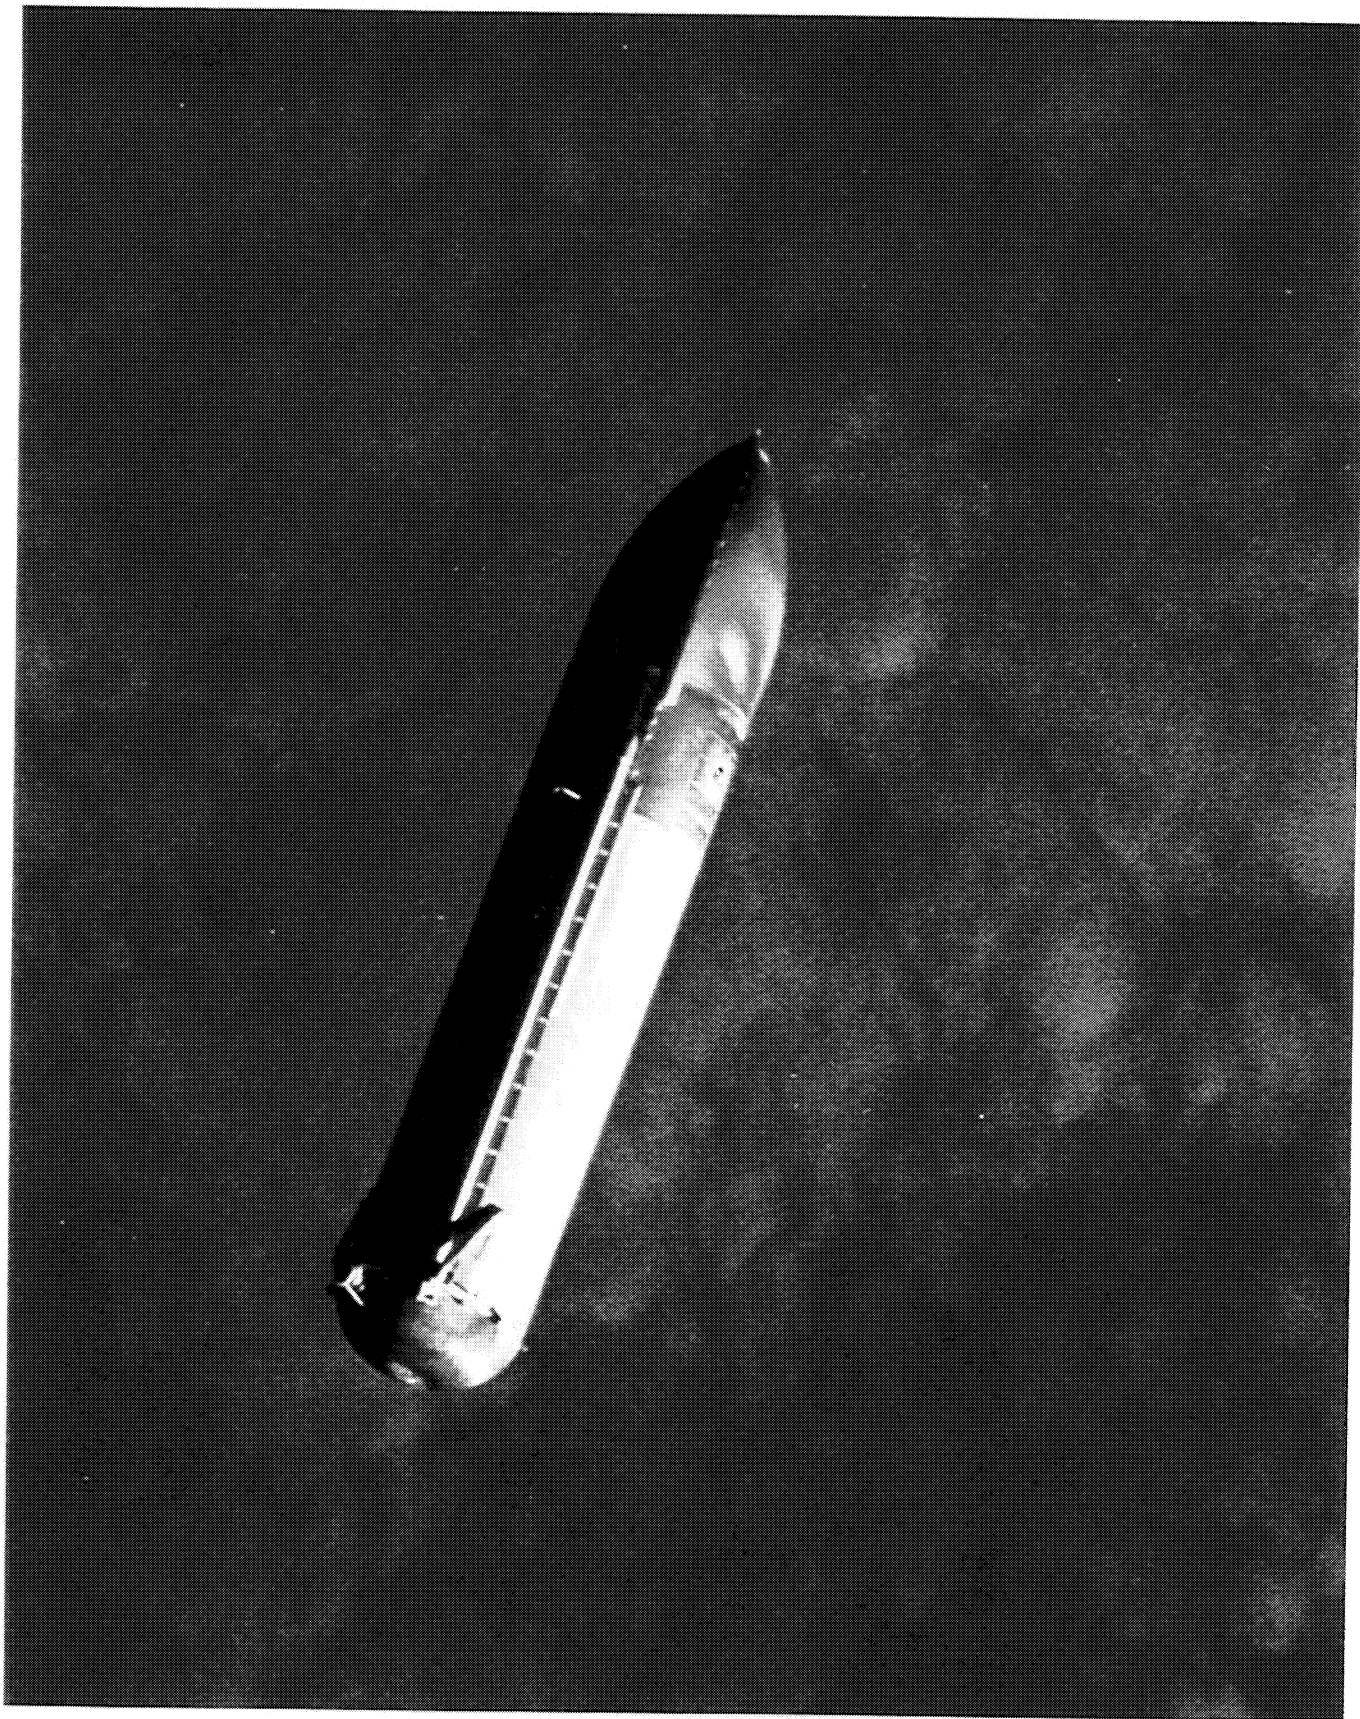
Photo 15: ET +Y Thrust Panel

The +Y thrust panel was imaged at a time when the ET was more distant and the resolution had degraded. The presence of divots could not be confirmed.
